# Aviation Investigation Final Report

<b>Location:</b>	Oshkosh, Wisconsin	<b>Accident Number:</b>	CEN23FA333
<b>Date &amp; Time:</b>	July 29, 2023, 12:27 Local	<b>Registration:</b>	N193AZ (A1); N221EL (A2)
<b>Aircraft:</b>	Rotorway 162F (A1); ELA ECLIPSE 10 (A2)	<b>Aircraft Damage:</b>	Destroyed (A1); Destroyed (A2)
<b>Defining Event:</b>	Midair collision	<b>Injuries:</b>	2 Fatal (A1); 2 Serious (A2)
<b>Flight Conducted Under:</b>	Part 91: General aviation - Personal (A1); Part 91: General aviation - Personal (A2)

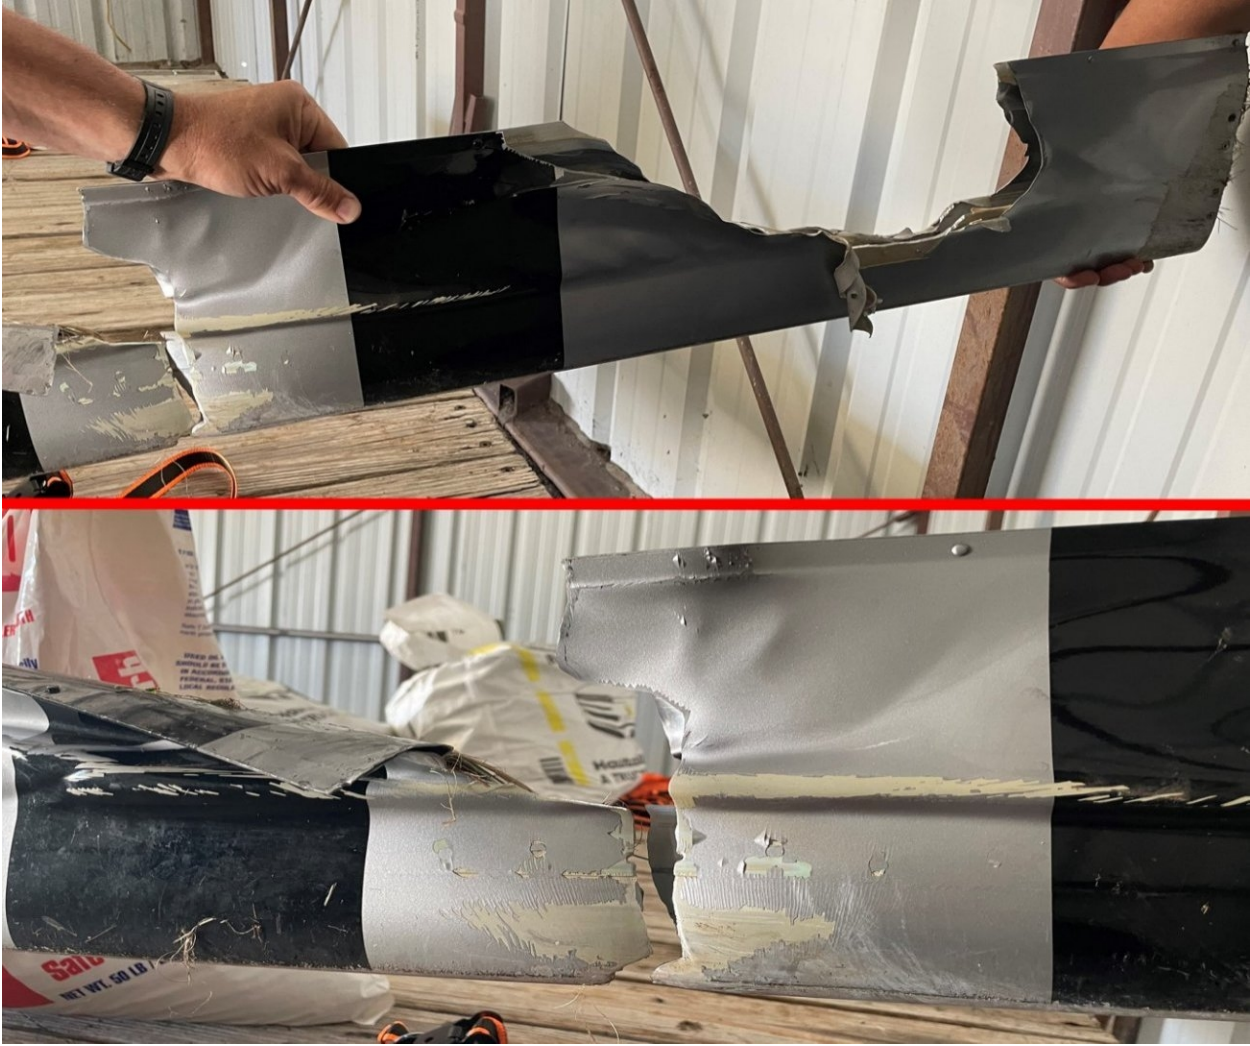
Postaccident examination of the helicopter revealed that both outboard sections of the main rotor blades were separated and came to rest in the debris field (see figure 4). The main rotor blade's structure displayed impact marks and white paint transfers, consistent with the gyroplane's structure and paint color.

Figure 4. Separated outboard sections of the helicopter’s main rotor blades.

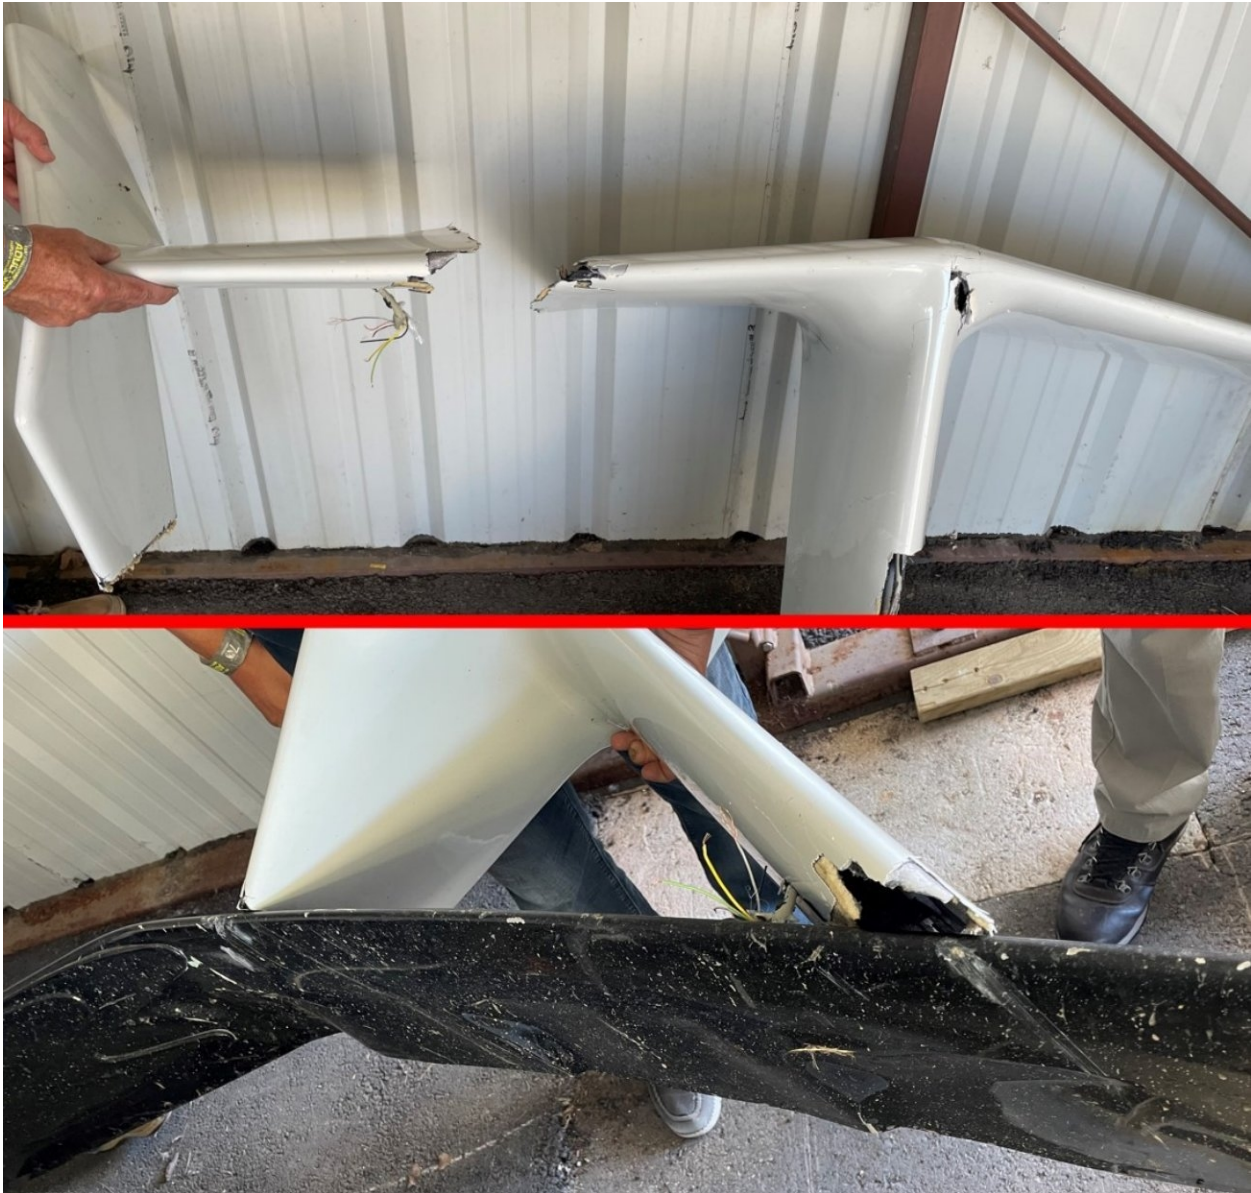
The gyroplane's right horizontal and vertical stabilizers displayed shear cuts and separated structure consistent with helicopter main rotor blade contact (see figure 5). The gyroplane's main rotor mast was separated about mid-length with an impact signature consistent with the helicopter's main rotor blade (see figure 6).

Figure 5. The upper photograph depicts the gyroplane's separated right horizontal stabilizer and lower vertical stabilizer. The lower photograph depicts the separated stabilizer section in comparison with the helicopter main rotor blade contact witness marks and white paint transfer.
